Electric Safety Test (EST) unit troubleshooting

Following instructions are applicable to both **ABAG** (ATB-ECO) and **GWinstek** (GPT-9804) electric safety tests units.

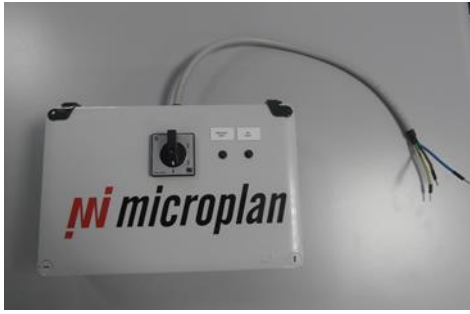
Possible problem	Possible solution																								
Electric safety test unit problem	<p>1. If a EST Check Box is available (see the picture) you should first execute the associated test procedure (read more) to troubleshoot the single test.</p>

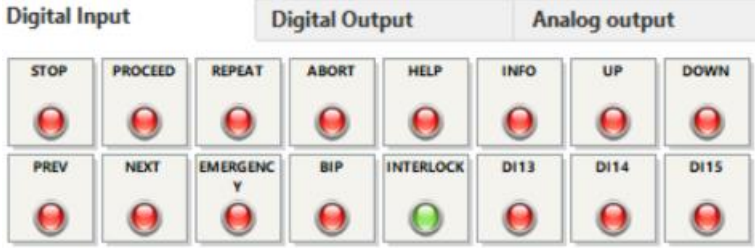
Interlock problem	<p>7. Make sure an appliance is plugged to the designated electrical socket</p> <ul style="list-style-type: none"> ○ Open the diagnostic program of the test bench; ○ Under the “Digital Output” tab make sure AS Appliance Supply (sometimes BS) command is OFF (red); ○ Under “Digital Input” activate SELHT (it should turn to green); ○ Press and hold both interlock push buttons simultaneously (on the electrical DER2 box) and check that signal is received by Microplan diagnostic program (INTERLOCK indicator shall turn to green color). <div style="text-align: center;">

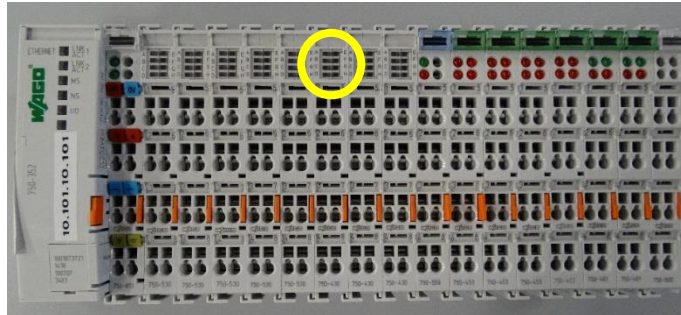
</div> <p>8. If not, press simultaneously both interlock buttons and check if the led (yellow circled in the following picture) of the associated digital input module (usually 750-530 from Wago) turns to green color.</p>	Digital Input			Digital Output			Analog output		STOP	PROCEED	REPEAT	ABORT	HELP	INFO	UP	DOWN	PREV	NEXT	EMERGENCY	BIP	INTERLOCK	DI13	DI14	DI15
Digital Input			Digital Output			Analog output																			
STOP	PROCEED	REPEAT	ABORT	HELP	INFO	UP	DOWN																		
PREV	NEXT	EMERGENCY	BIP	INTERLOCK	DI13	DI14	DI15

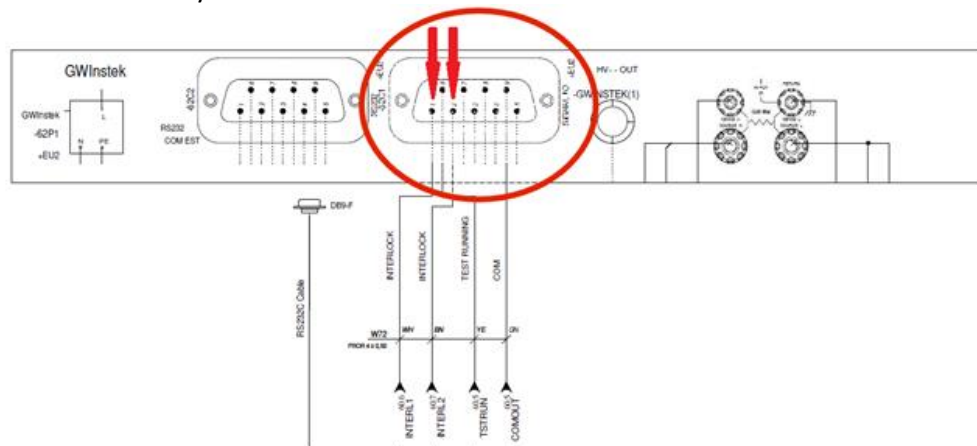
9. Inside the electrical cabinet check the integrity of the comparator fuse, replace if necessary;
10. With the door of the electrical cabinet open
 - Use the diagnostic program of the test bench, under “Digital Input” activate SELHT (it should turn to green);
 - Press simultaneously both interlock buttons and check that the led onboard the comparator changes its status;
11. Disconnect the DB9 connector of the EST GwInstek unit and check with a multimeter if there is continuity between pin1 and pin2 with both interlock buttons pressed. Be aware that the INTERLOCK circuit is under the control of the safety device, therefore the double INTERLOCK push buttons must be pressed together at the same time and kept pressed throughout the duration of the electric safety tests.

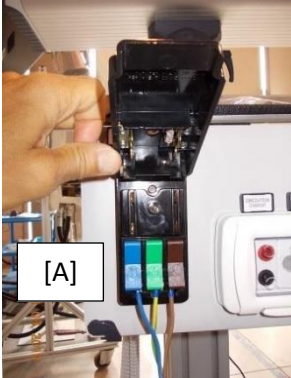
Possible problem	Possible solution
<p>3-wires cable not correctly inserted</p>	<p>12. (when applicable) Ensure the 3-wires of the appliance cable are correctly inserted into the socket [A]. Sometimes 3-wires end electric rods are too short [B] to make contact with the socket. As a trial remove the electric rods from the 3-wires cable and plug its own copper wires [C] directly into the socket.</p> <div style="display: flex; justify-content: space-around;"> <div style="text-align: center;">

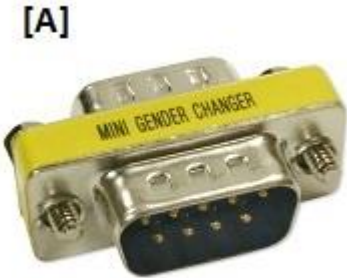
<p>[A]</p> </div> <div style="text-align: center;">

<p>[A]</p> </div> </div>
<p>PC COM port damaged</p>	<p>13. Contact Microplan Support</p>
<p>GWinstek unit wrong settings (not for ABAG units)</p>	<p>14. Read the document GWinstek initial settings</p>
<p>Serial cable problem</p>	<p>15. Replace the serial cable. The PC COM port and the electric safety test unit COM port are both RS232 DB9 male. Therefore one of the following 4 configurations is allowed:</p> <ul style="list-style-type: none"> a) crossed cable RS232 DB9 female/female (<u>preferred</u>) b) crossed cable RS232 DB9 male/female + gender changer [A] c) not crossed cable RS232 DB9 female/female + null modem [B] d) not crossed cable RS232 DB9 male/female + gender changer [A] + null modem [B] (<u>recurrent</u>) <div style="display: flex; justify-content: space-around; margin-top: 20px;"> <div style="text-align: center;">
