Siemens MXG proportional control valves troubleshooting

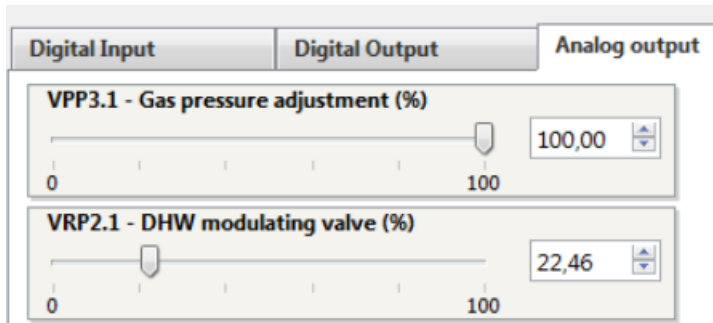
Possible problem	Possible solution
Valve problem	Enter the diagnostic application of the test bench, move the proportional valve cursor from 0 to 100% and: <ul style="list-style-type: none"> visually check that the stroke (spring) of the valve moves in accordance check that a change of the flowrate is produced in the same circuit

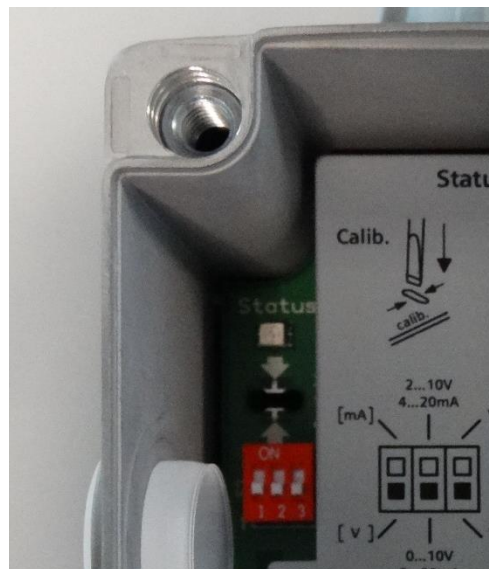
1. ensure there is no pressure in the circuit where the proportional valve is installed, evacuate water if needed;
2. remove the protective cover to access the printed circuit board where you'll find a slot for the autocalibration (position 3):

Here is the procedure to execute the **valve calibration**:

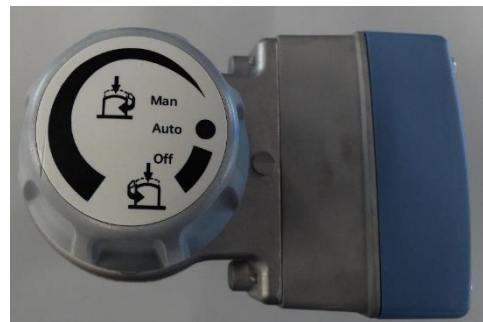
- Make sure the top knob is set to Auto
